Milestone Phase One Inspection Report
Condominium Association

June 12, 2023

Name on Title:	Seaside Retreat Condo
Year Constructed:	1999
Building Street Address:	8030 First Coast Highway Fernandina Beach, FL 32034
Legal Description:	00-00-30-0607-0000-0000
Building Code Occupancy Classification:	R-2
General Description of Building:	High rise
Number of Buildings:	2
Number of Stories:	7
Threshold Building as Per 553.71(12) F.S.	Yes
Plans on Site/Available:	No
Additions to Original Structure:	No
Total Actual Building Area of all Floors (S.F.)	Estimated 61,964 SF

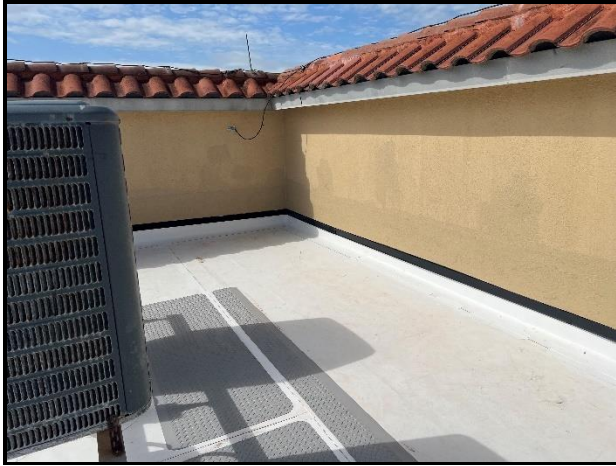
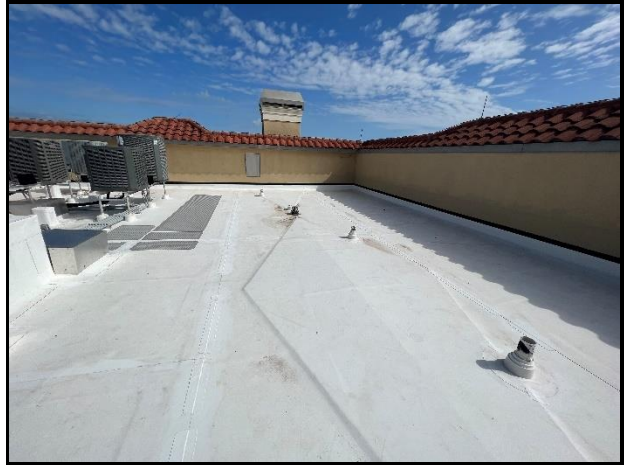
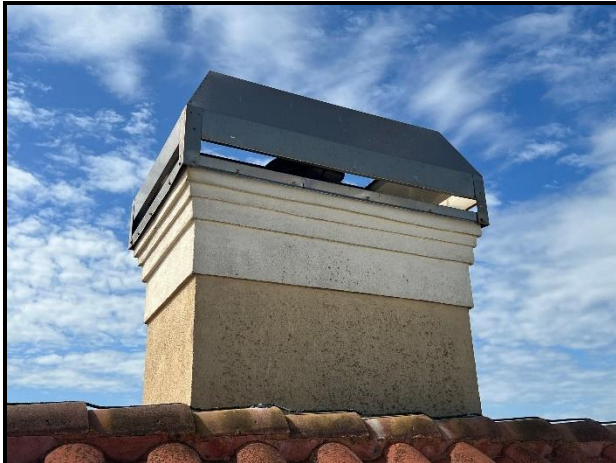
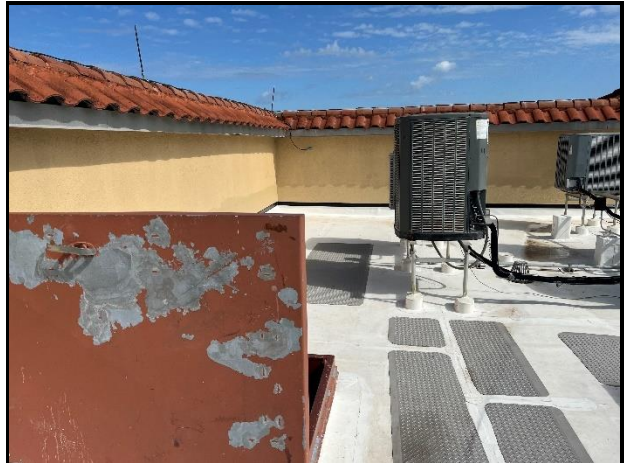
The primary low-slope roofs are new assemblies.

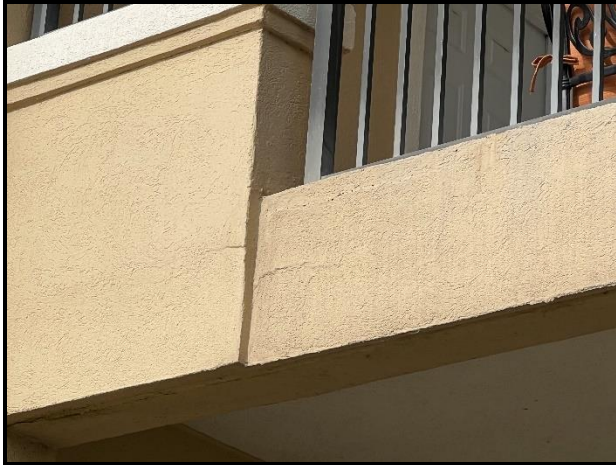
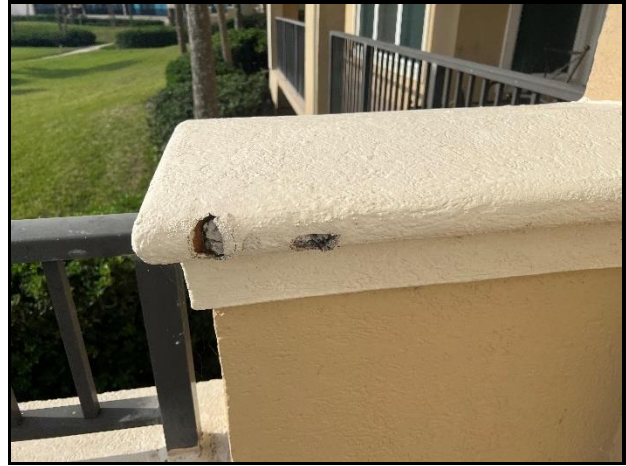
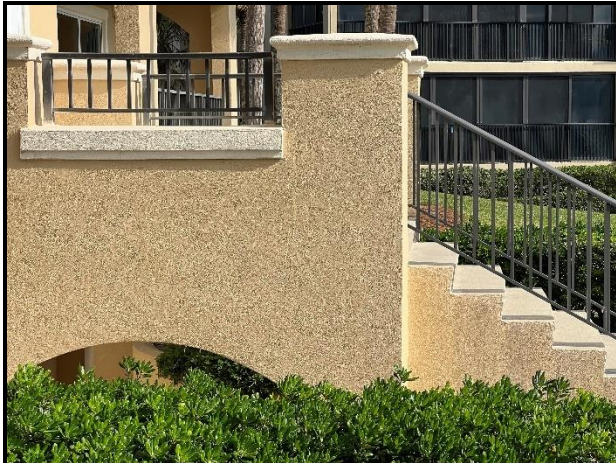
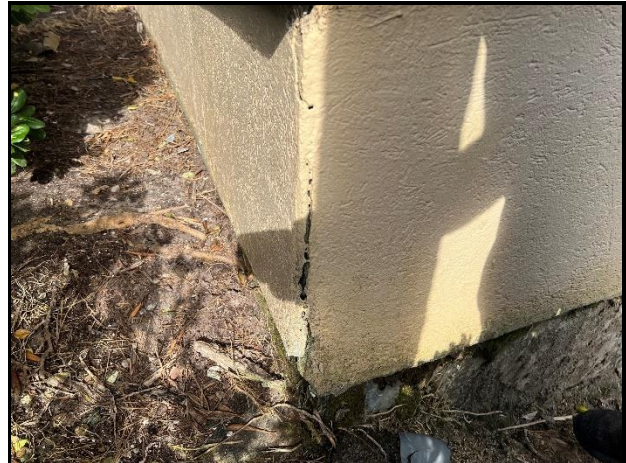
There are areas in need of repair and/or maintenance to address cracks and damage with the EIFS cladding.

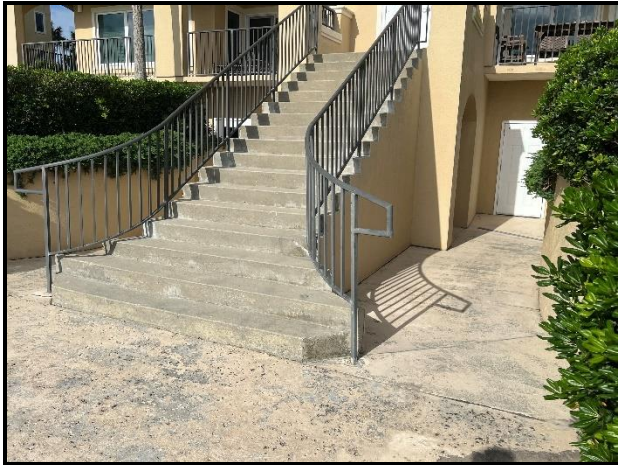
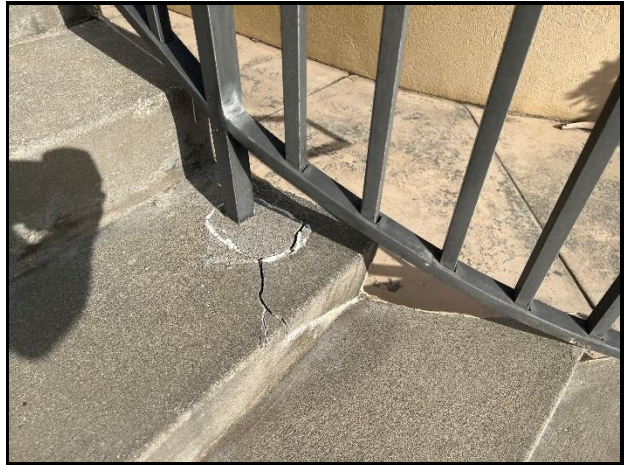
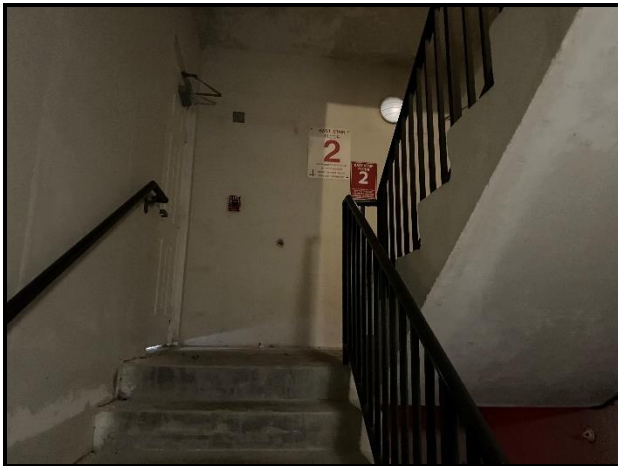
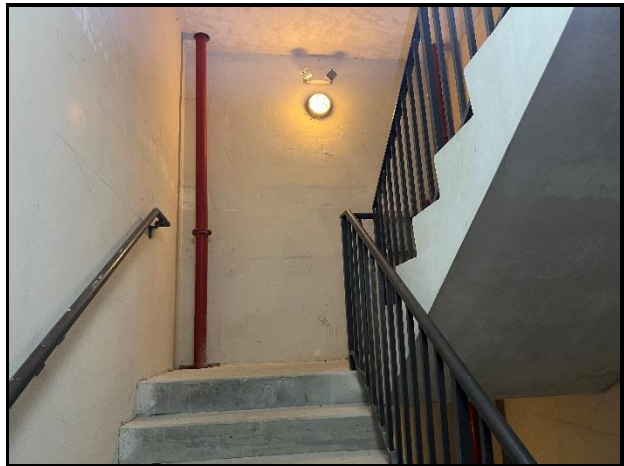
Additional Comments:
The rear stair tower of the north building has experienced a minor amount of settlement. Also, there is concrete spalling at the corners of the steps where the rails are core mounted. Lastly, these exposed concrete stairs are recommended to be waterproofed.

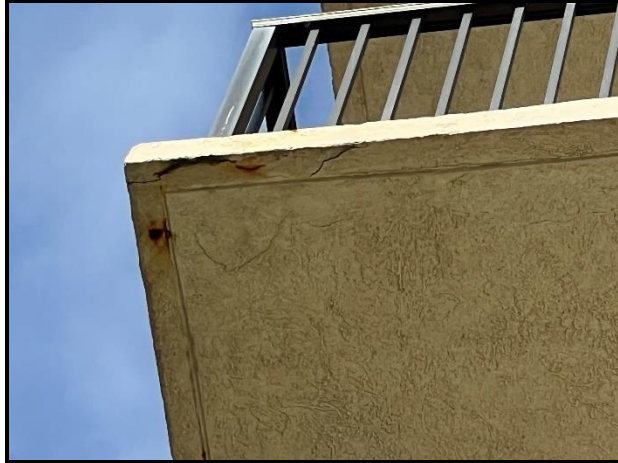
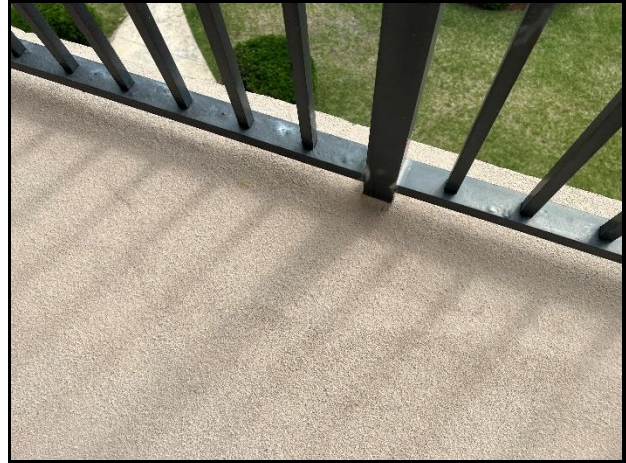
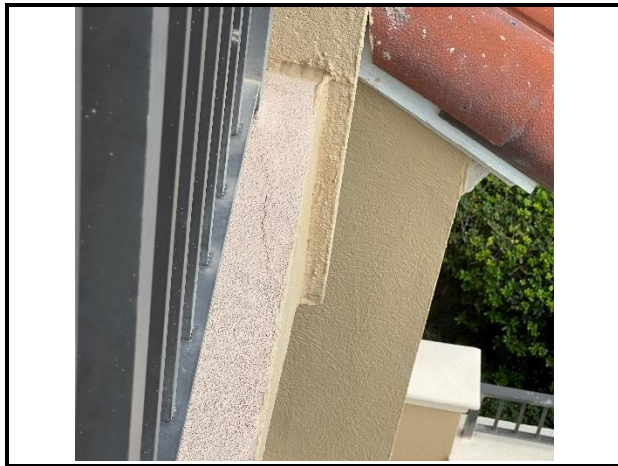
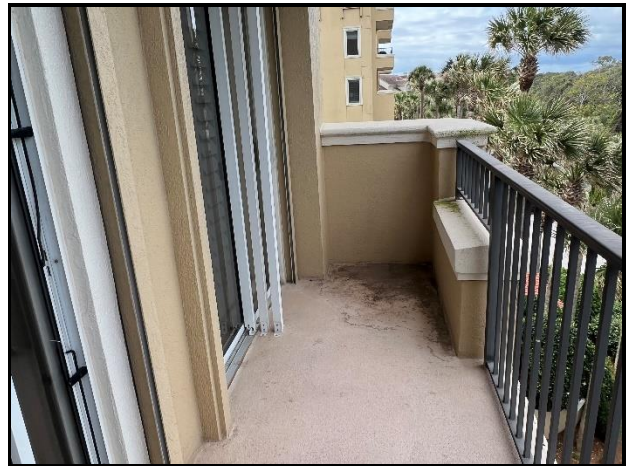
Additional Comments:
Multiple balconies were noted to have minor cracks and spalls; particularly at the edges and near or adjacent to the core mounted stanchion posts.

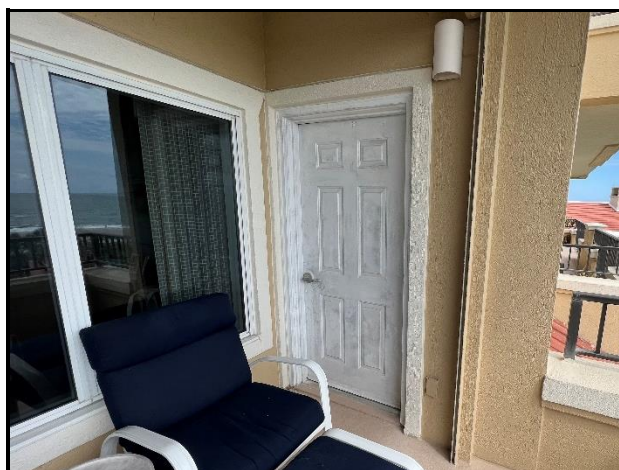
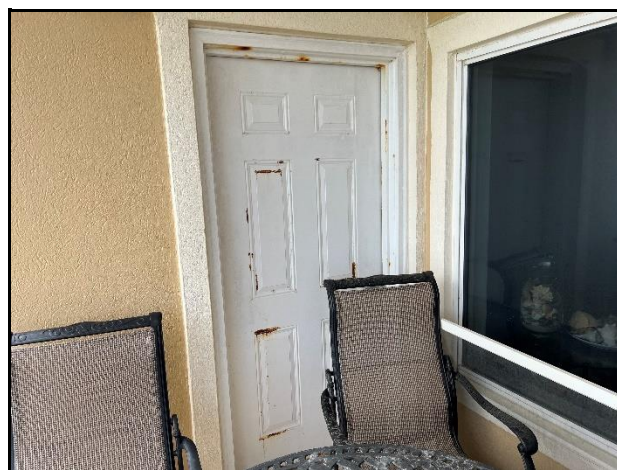
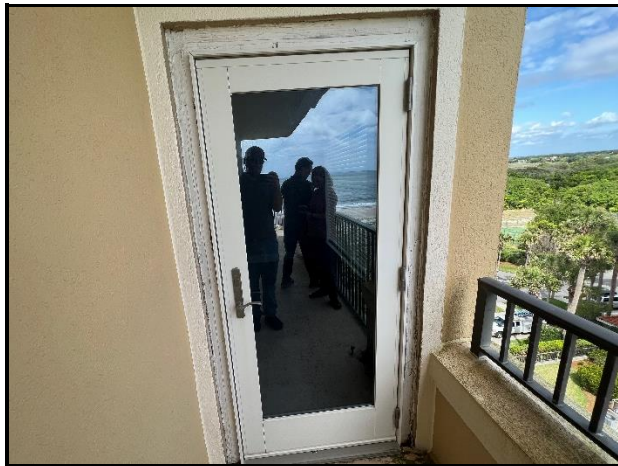
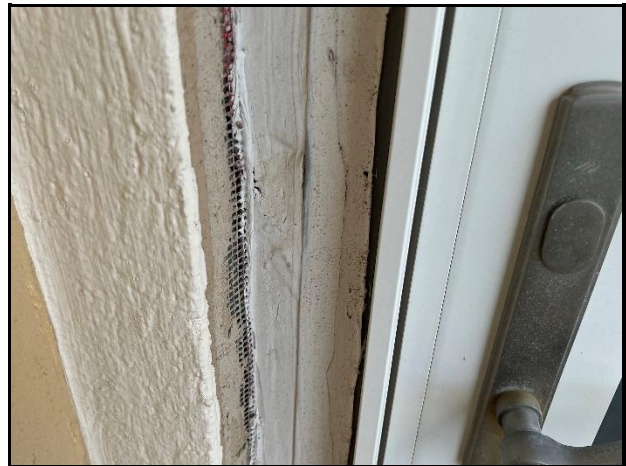
Additional Comments:
 The side balcony door of unit 211 was improperly installed and has large gaps in the sealant around the door frame.

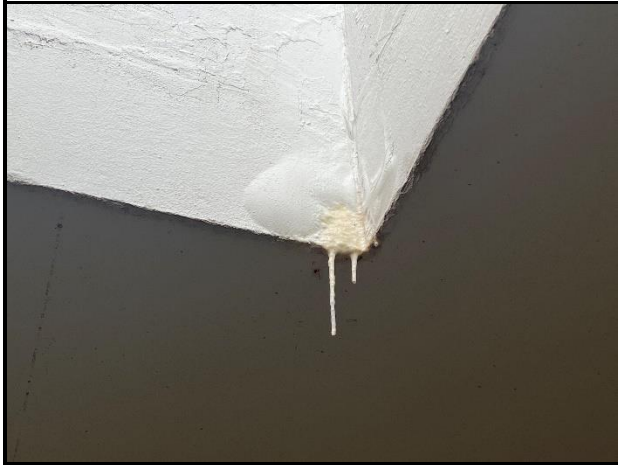
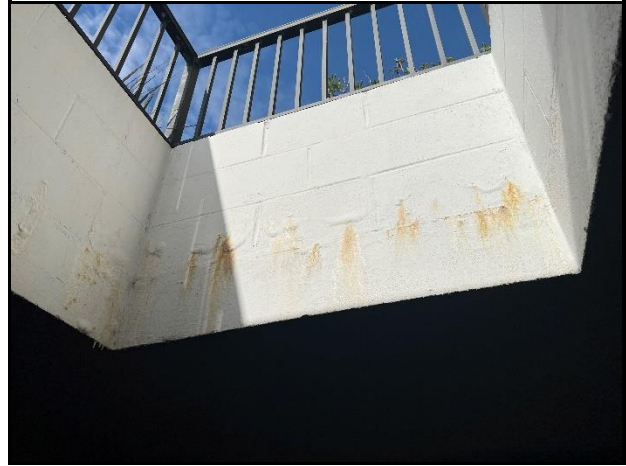
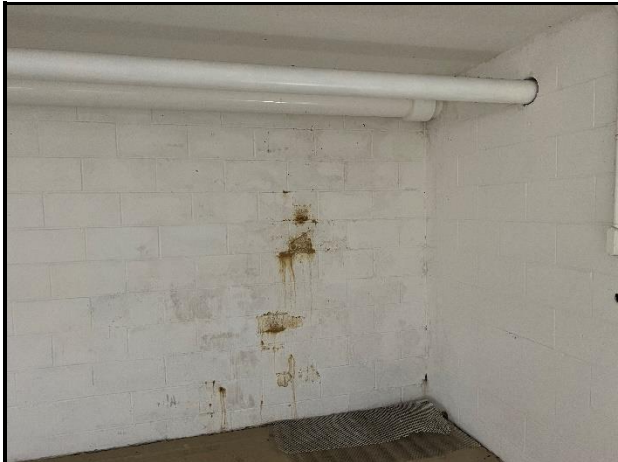
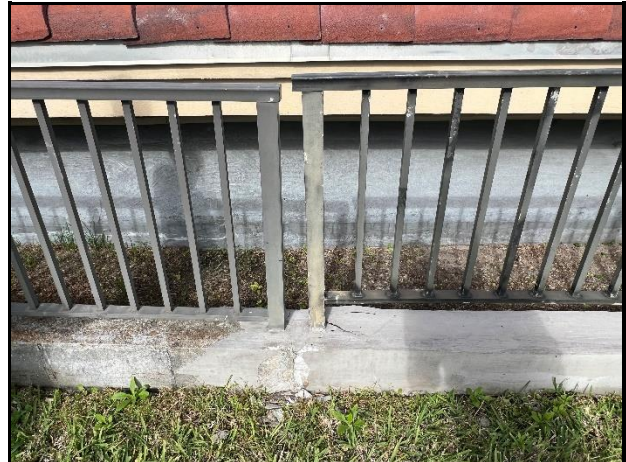
Additional Comments:
Skylight openings showed signs of water intrusion. Wall staining and signs of water intrusion can be found in the SW corner of Building 1 garage and the NW corner of Building 2 garage. A small retaining wall runs above where these locations meet, this retaining wall shows signs of movement and previous repair. The below grade waterproofing above the parking garages should be inspected, and repaired or replaced as necessary.
