Seaside Retreat Condominium Association, Inc.

## **Structural Integrity Reserve Study**

For Period Beginning January 1, 2025

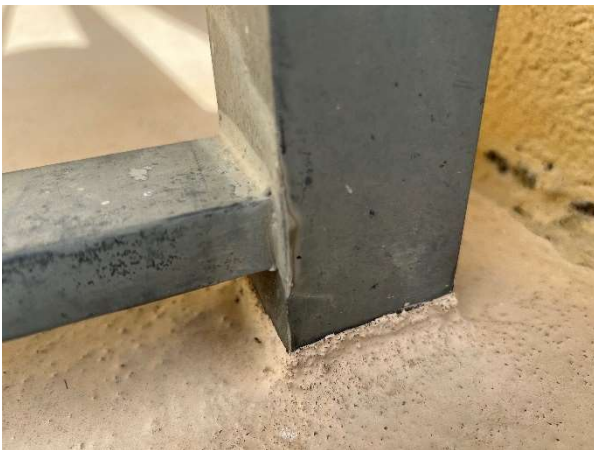
Railings embedded in concrete balconies

**Recommendation Notes:** Our estimate of is based on actual current project costs includes close-up visual inspections, patching of delaminated concrete, routing and filling of cracked concrete, and applying waterproof coatings. We advise coordinating with future facade repairs to reduce costs and disruption.

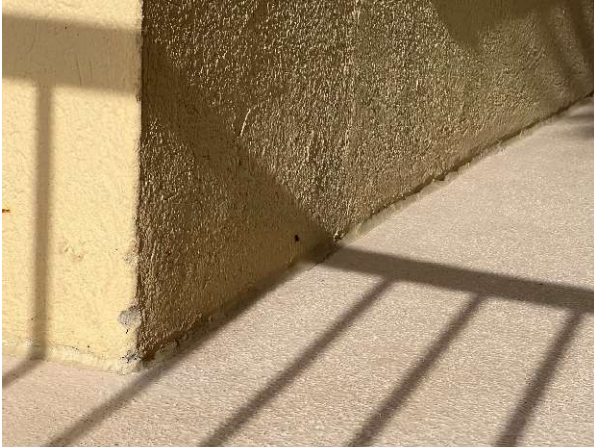
Concrete balcony joint to building

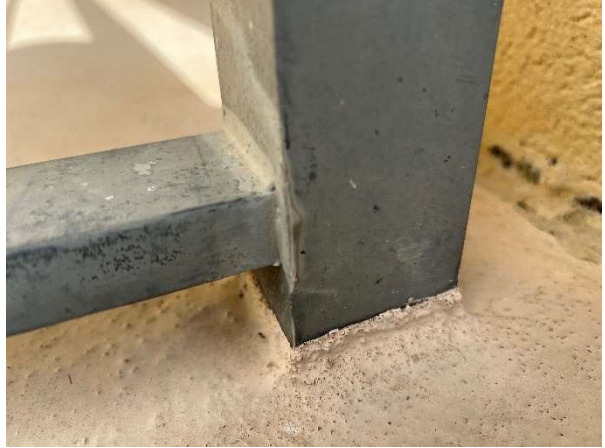
Railings embedded in concrete balconies

**Recommendation Notes:** We recommend balcony rail replacements be surface-mounted and secured using epoxy set directly into the concrete balconies. This method ensures a strong, durable attachment while minimizing the risk of water intrusion or damage to the concrete structure. Our estimate of cost is based on actual near term project costs.

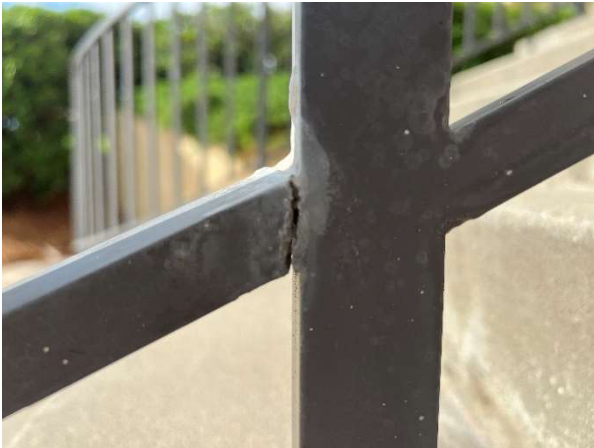
Railing damage at rear steps

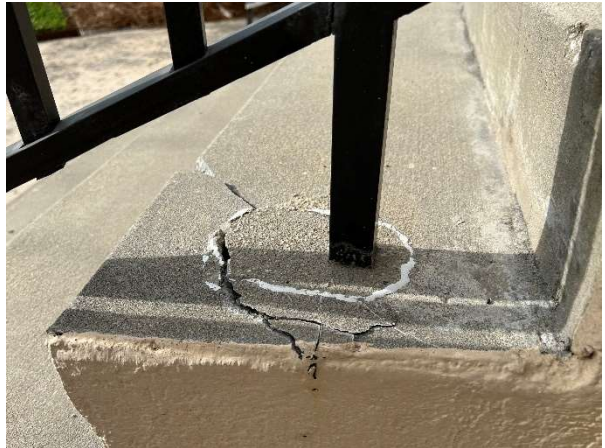
Railing and concrete damage at rear steps

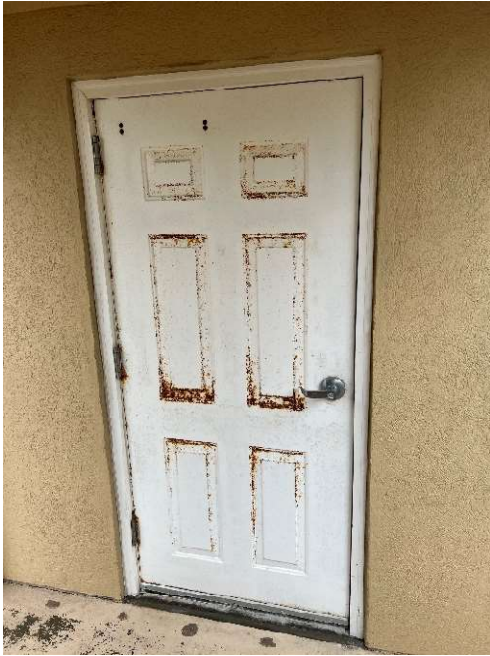
Rust evident at exterior doors

**Recommendation Notes:** The Association will replace the remainder of the doors in the near term with Fiberglass Reinforced Plastic (FRP) doors. Our estimate of cost is based on actual near term project costs.

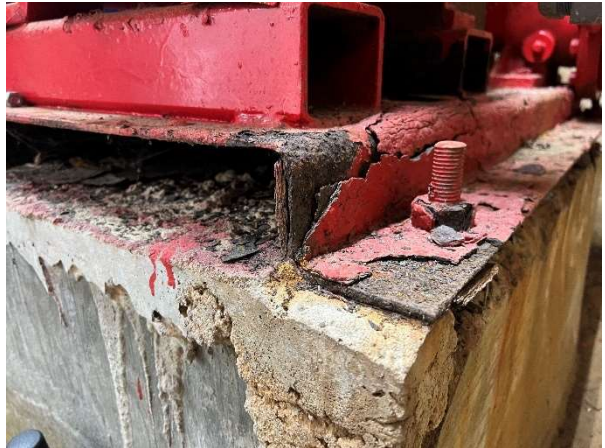
Corroded frame and mount

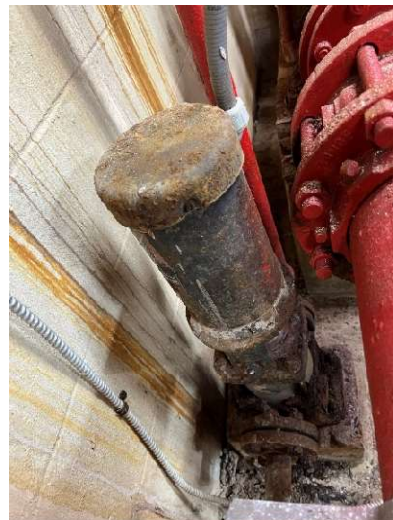
Corroded jockey pump

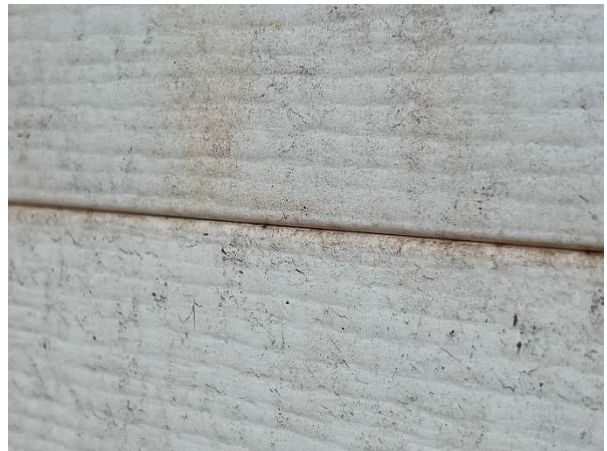
Faded and deteriorated finishes at garage door

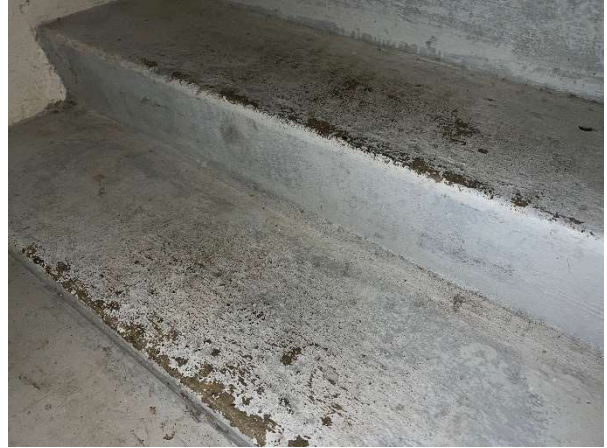
Tread coating deterioration

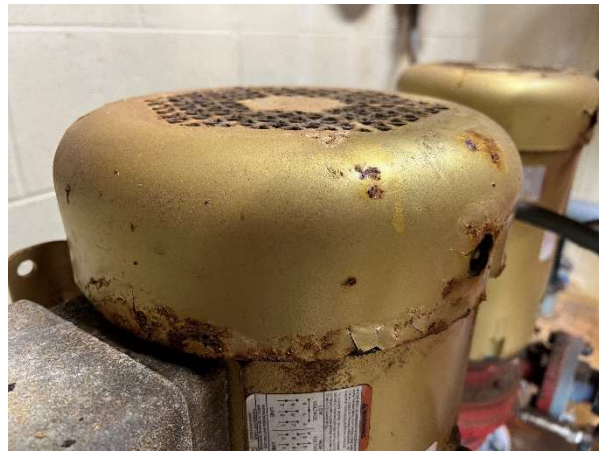
Corrosion evident at pump shell

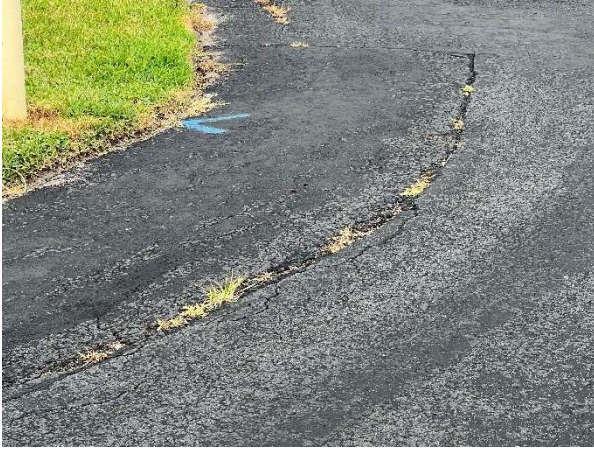
Cracks with vegetative growth evident

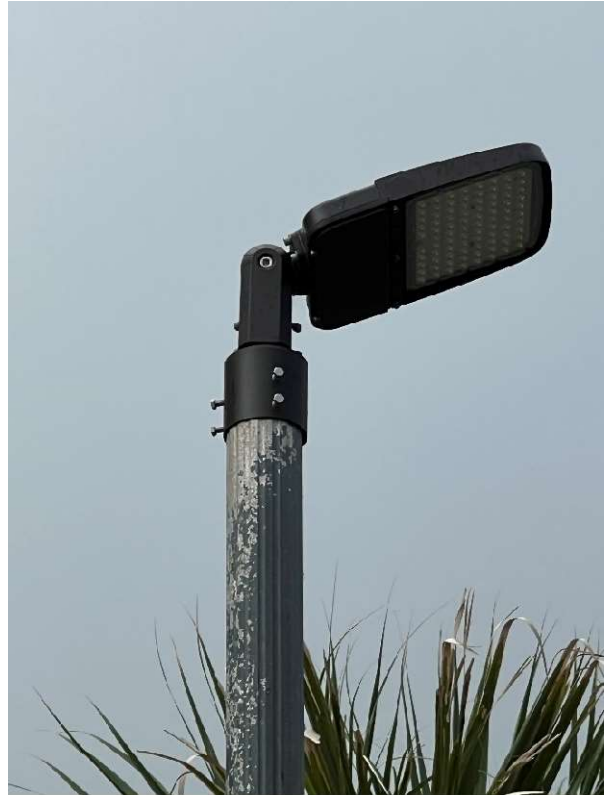
Recently replaced fixture with pole finish deterioration

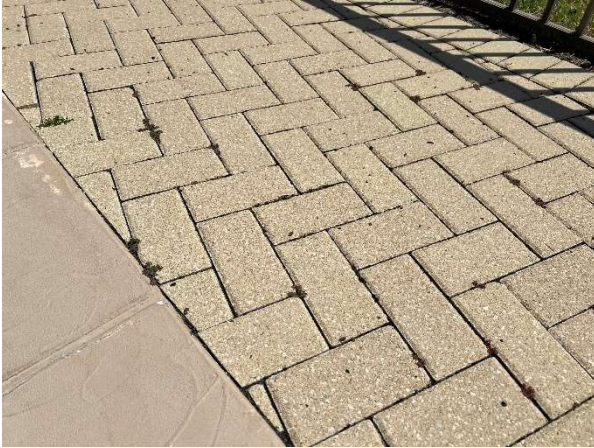
Minor vegetative growth

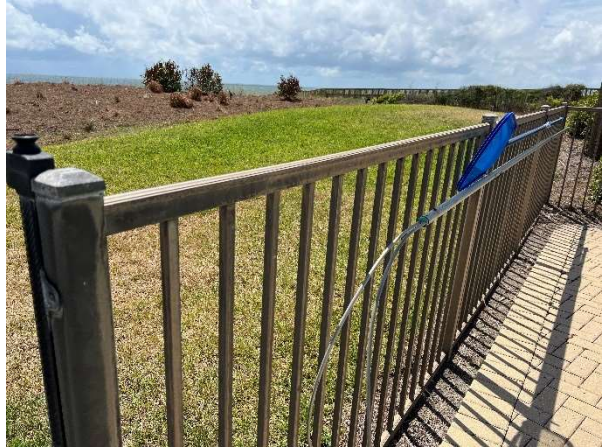
Finish deterioration

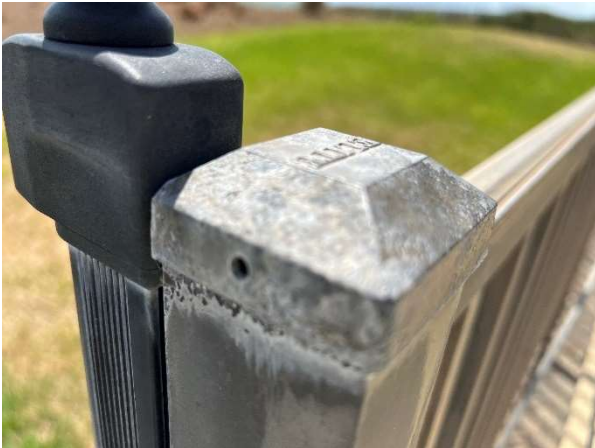
Post cap deterioration
