**Exterior & Below-Grade Renovation Project Completion Report  
(Project Completed May 1<sup>st</sup> 2026)**

Seaside Retreat Condominium Association  
Amelia Island, Florida 32034

**Project Start Date: March 17, 2025**  
**Project Completion Date: May 1, 2026**

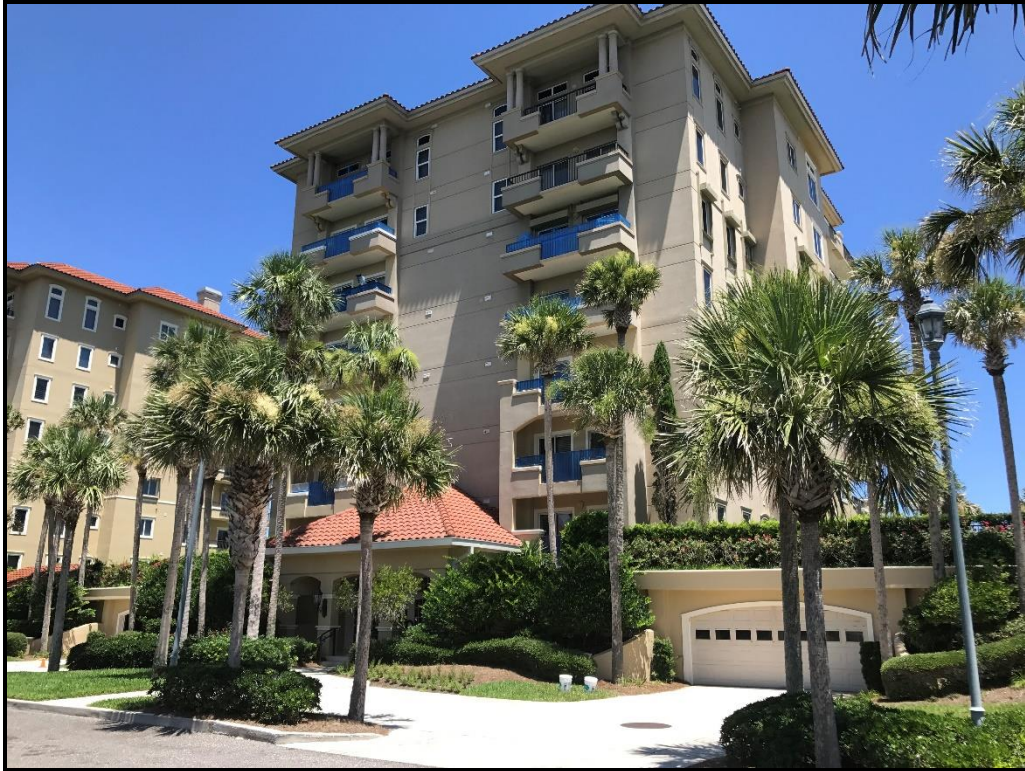
**Photograph 1. Building 2 – Before construction.**

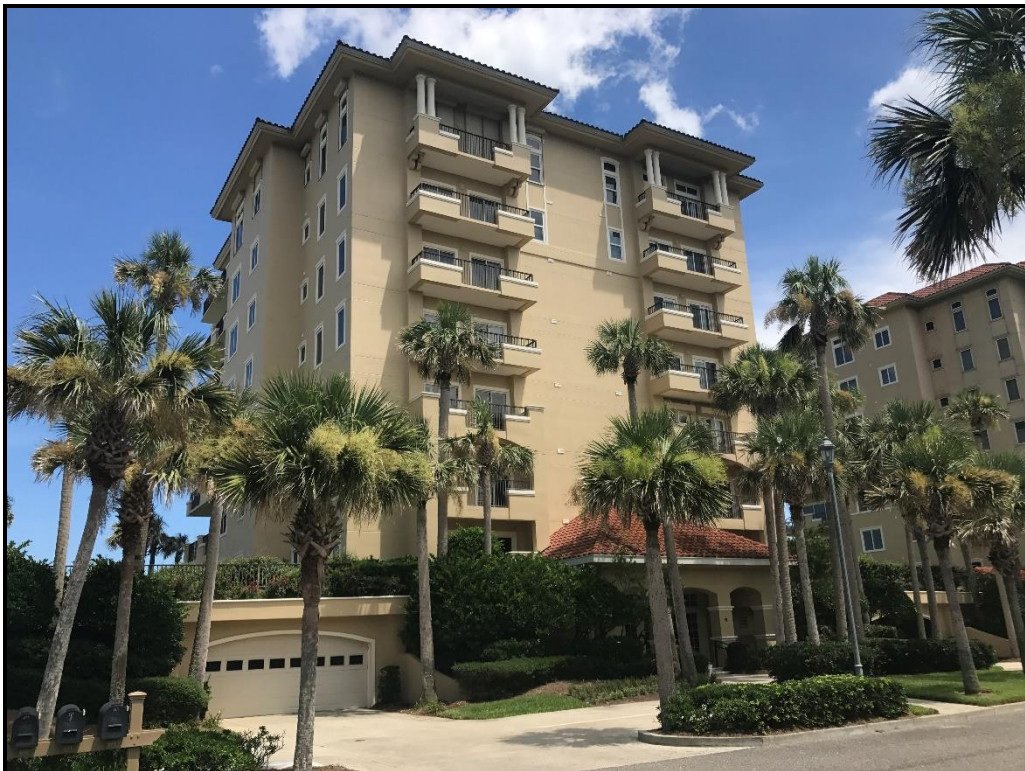
**Photograph 2. Building 1 – Before construction.**

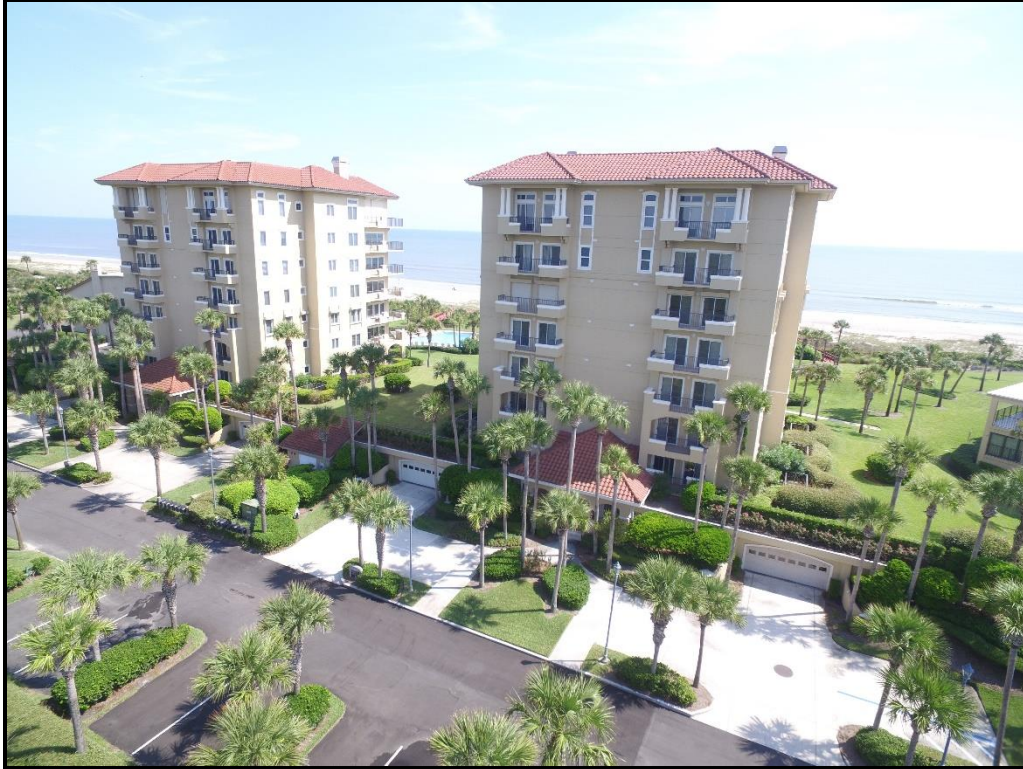
**Photograph 3. Property overview – Before construction.**

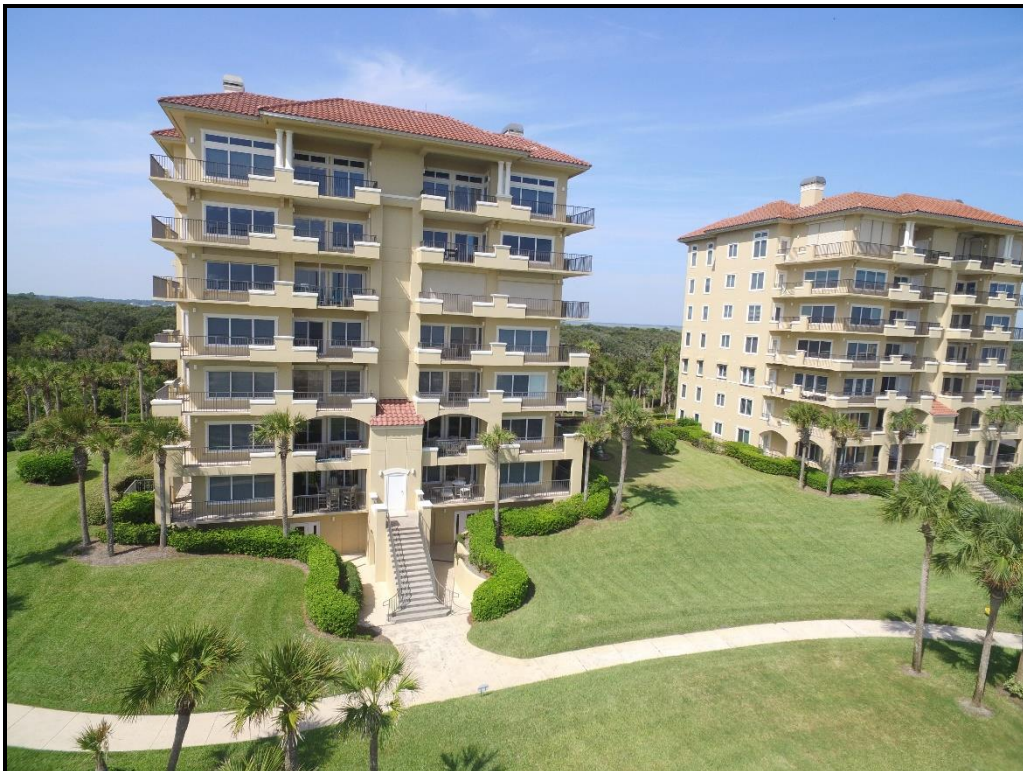
**Photograph 4. Building 2 – Before construction.**

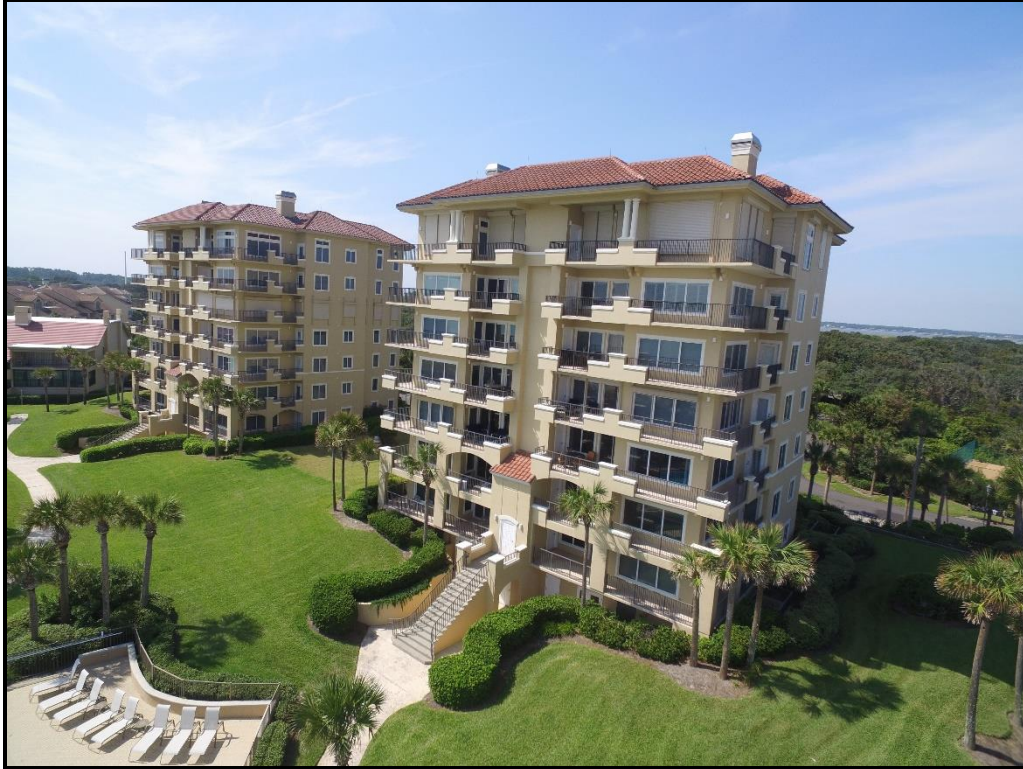
**Photograph 5. Building 1 – Before construction.**

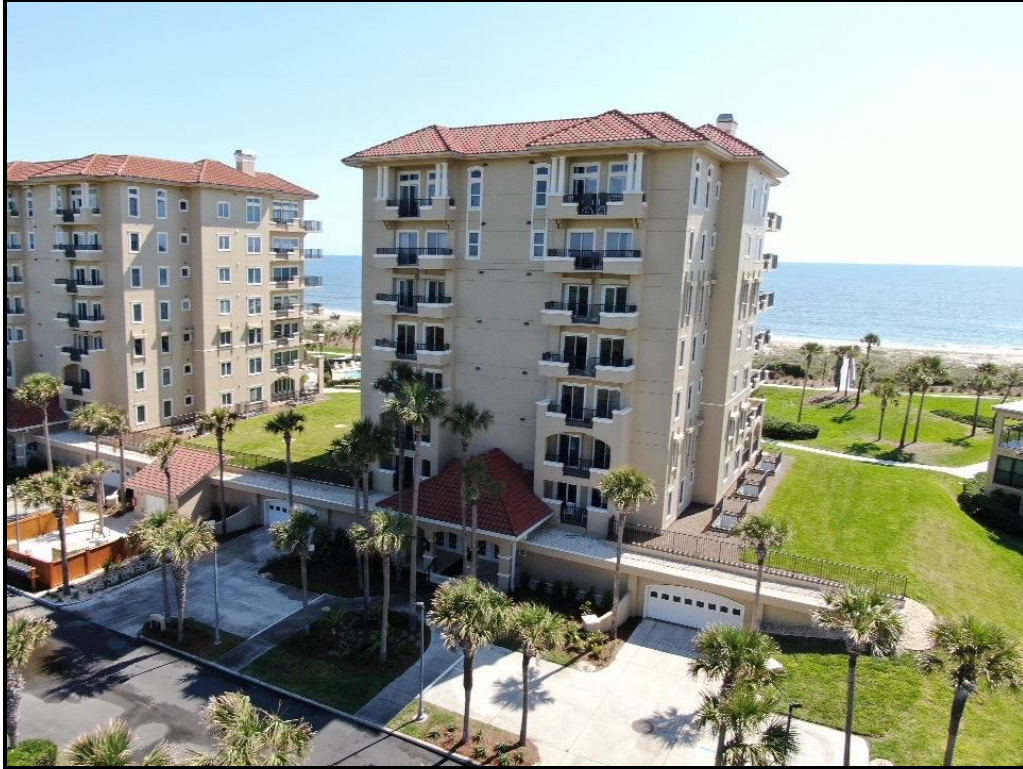
**Photograph 7. Property overview – After construction.**

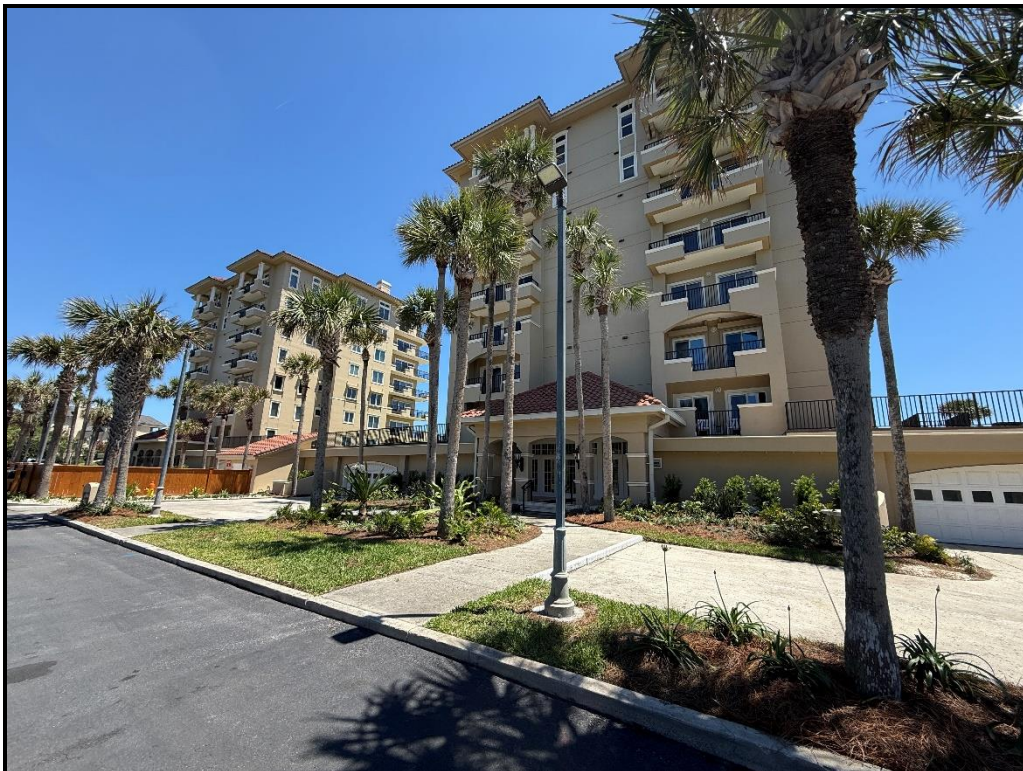
**Photograph 8. Building 2 front overview – After construction.**

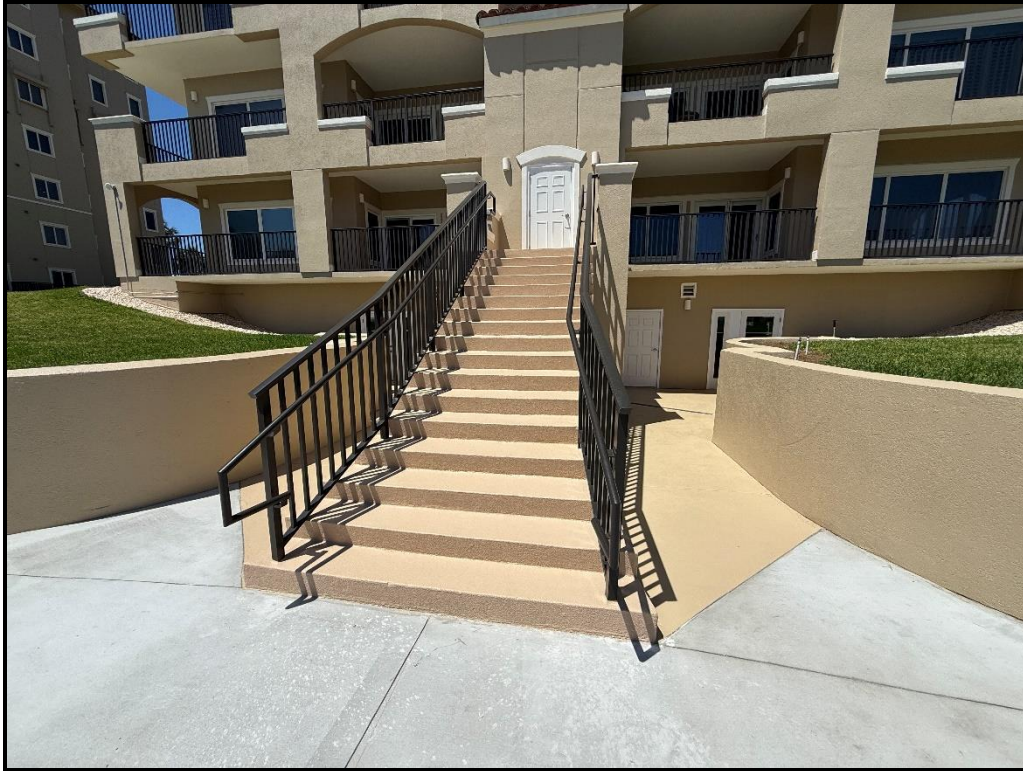
**Photograph 9. East stairwell staircase – After construction.**

Traffic Coatings (Sikalastic 220/225) - The new Sikalastic 220/225 traffic coating system on balconies and east staircases is designed for high durability and waterproofing under foot traffic. Regular inspection will ensure the waterproofing system is performing as intended and providing protection to the buildings' structural components. Refer to manufacture recommendations for cleaning and maintenance.

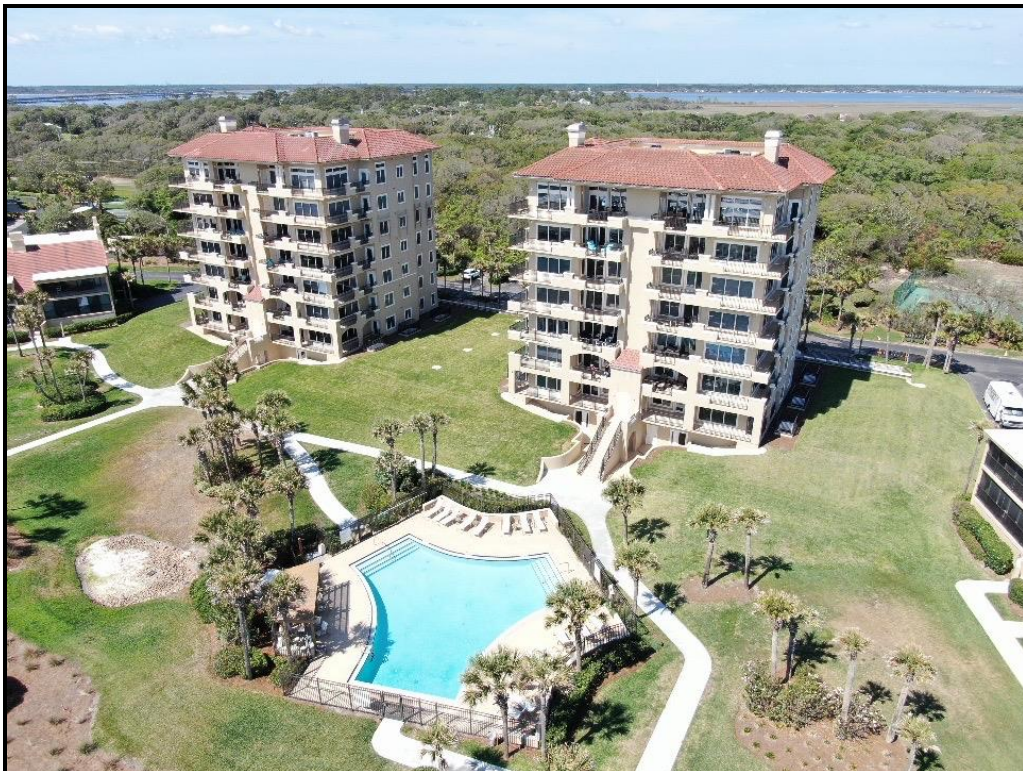
**Photograph 10. Property overview – After construction.**
