Milestone Phase One Inspection Report
Condominium Association

June 12, 2023

Name on Title:	Seaside Retreat Condo
Year Constructed:	1999
Building Street Address:	8030 First Coast Highway Fernandina Beach, FL 32034
Legal Description:	00-00-30-0607-0000-0000
Building Code Occupancy Classification:	R-2
General Description of Building:	High rise
Number of Buildings:	2
Number of Stories:	7
Threshold Building as Per 553.71(12) F.S.	Yes
Plans on Site/Available:	No
Additions to Original Structure:	No
Total Actual Building Area of all Floors (S.F.)	Estimated 61,964 SF

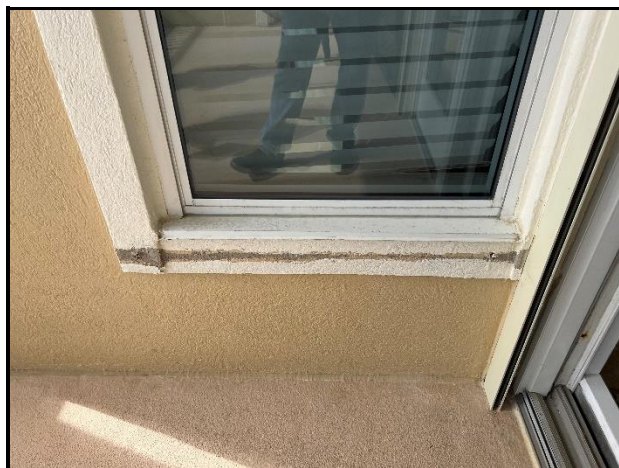
Photograph 21.

Found during inspection (Select all that apply):			
<input type="checkbox"/> Pitting	<input checked="" type="checkbox"/> Paint Peeling	<input type="checkbox"/> Broken Glass	<input checked="" type="checkbox"/> Corrosion
<input type="checkbox"/> Deterioration	<input type="checkbox"/> Broken Hardware	<input type="checkbox"/> Corroding Hardware	<input type="checkbox"/> Missing Hardware
<input type="checkbox"/> Other:
